REPAIR INSTRUCTIONS - P300 SERIES - 16 & 18 MM VERSIONS

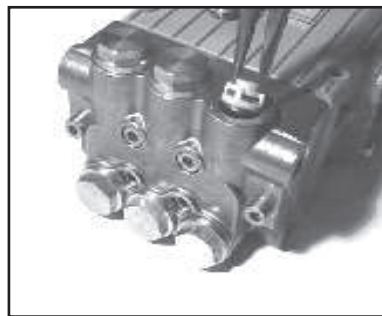
2. Using a needle nose pliers, remove the inlet and discharge valve assemblies (#32X).

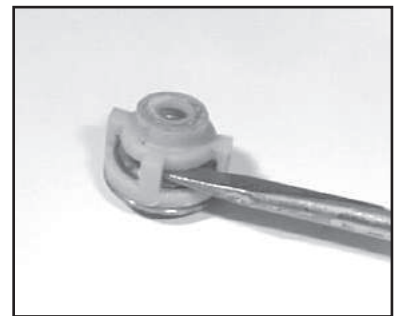
3. The valve assemblies can be separated by inserting a small screw driver between the valve seat (#27) and its valve spring retainer (#30).

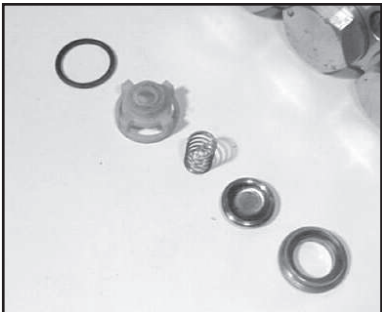
4. Remove each o-ring (#31). Inspect all parts for wear and replace as necessary. Reassemble valve assy's (32X) & place in valve casing (26)

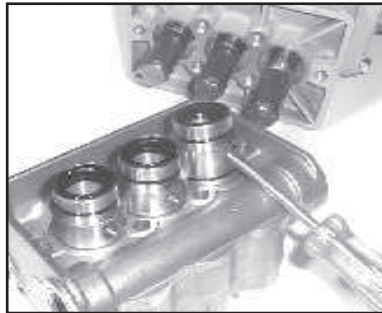
8. Remove weep return rings (#25) from the plungers (#16). Remove the seal case (#20) from either crankcases (#1) or manifold (#26) by using a screwdriver as shown above.

NOTE: If there are deposits of any kind (i.e., lime deposits) in the valve casing, be certain the weep holes in the weep return ring (#25) and valve casing (#26) have not been plugged.

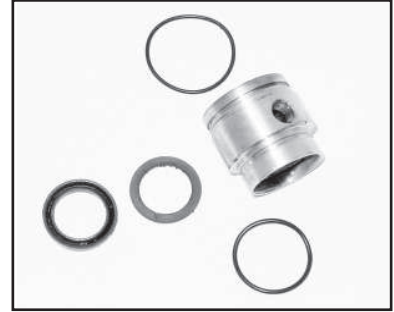
11. Inspect o-rings (#21 and 22) and replace as necessary.

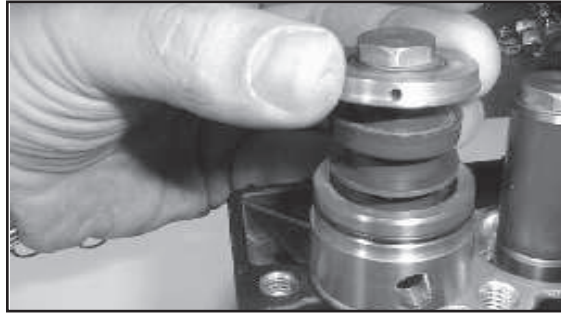
Reassembly sequence of the P300 Series pump

14. If the oil seals (#19) were removed, replace them with the primary seal lip (grooved side) towards the crankcase and the dust lip (tapered end) towards the valve casing (#26). Lubricate the seal before replacing. Install the oil scraper (#18) over the plunger.

15. Place each seal case (#20) with o-rings (#21, 22) over the plungers (#16). Be certain the oil seal is centered with the seal case and tap firmly until the seal case is seated squarely on the crankcase (#1). Place pressure ring (#24) in seal case).

16. With the grooved side pointed toward the valve casing, place the weep grooved seals (23A) over each plunger and into each seal case (#20).
17. Generously lubricate the grooved seals (#23) and assemble these items into the valve casing. Place the weep return rings (#25) onto each plunger (#16). Place the pressure rings (#24) over the plungers. Slide the valve casing over the plungers and seat firmly. Replace the 6 hex head cap screws (#34) and tighten to 216 in.-lbs. in a crossing pattern.
